COMMENTARY / SAVVY AVIATOR

Diagnostic Tales From the War Zone

Troubleshooting is best accomplished by first gathering data and then analyzing it logically

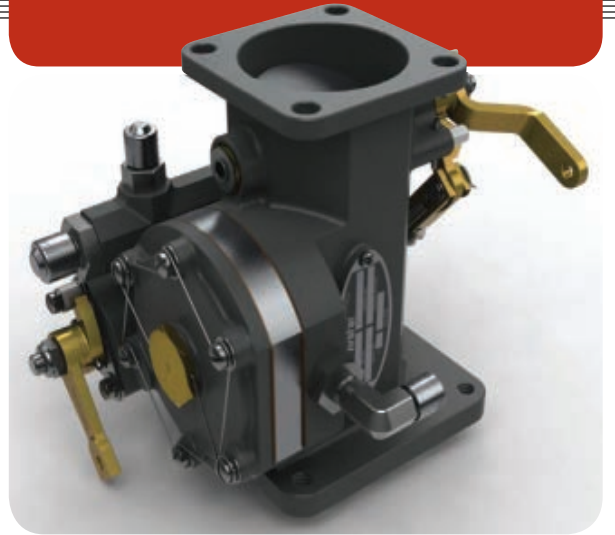
Figure 1—Two local mechanics decided that the RSA fuel servo was the culprit.

The owner took the aircraft to a local mechanic, who ran the engine and concluded that the RSA fuel servo was at fault. He discussed the problem with another technician, who agreed with his diagnosis. The mechanic proposed to remove the RSA fuel servo and overnight it out to Precision Airmotive for bench testing and repair. This would leave the aircraft grounded and the owner stranded in Key West for a week. The estimated cost for an overhauled fuel servo was about \$2,000.

Lycoming "morning sickness" caused by a sticky exhaust valve. Paul explained to the owner that the symptoms could not possibly be caused by a faulty RSA fuel servo, since there is no way that a fuel servo problem could affect just one cylinder.

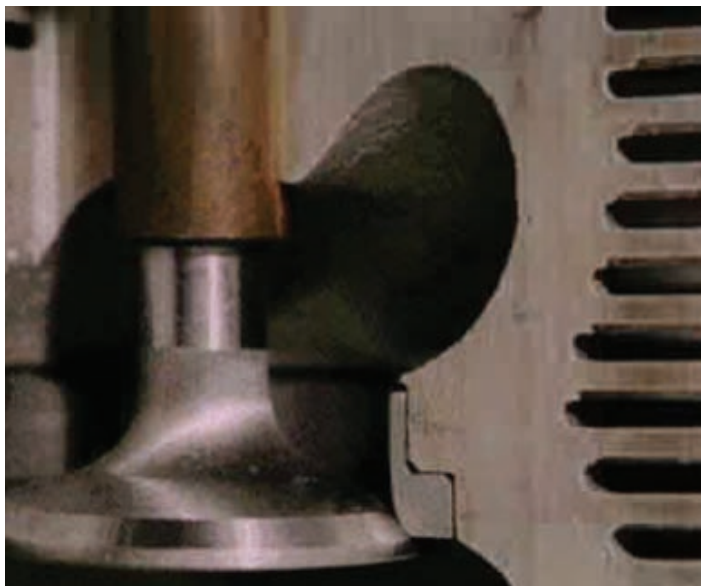
Fortuitously, the G1000 system in the T182 had recently been upgraded to provide data logging, so Paul had the owner insert an SD memory card into the G1000 and do another ground run so that the data could be captured and uploaded to our SavvyAnalysis.com platform. When Paul reviewed the engine data, it was clear that the data was not consistent with a clogged injector or any other fuel system problem. Cylinder No. 3 was producing meaningful EGT (so it was getting fuel and spark), but was not producing meaningful CHT (so it wasn't producing power). Those findings were consistent with an exhaust valve that was not fully closing.

At Paul's suggestion, the local mechanic removed the spark plugs from cylinder No. 3 and predictably found them to be oil fouled. After cleaning the

Figure 2—Lycoming “morning sickness” is caused by buildup of exhaust deposits on the exhaust valve stem and inside the exhaust valve guide. The cure is to clean the valve stem and ream the valve guide, something that can be done without removing the cylinder.

plugs, the engine ran a bit better. The engine smoothed out after several more ground runs, reinforcing Paul's diagnosis of a sticky No. 3 exhaust valve (which would be worst when cold and would free up as it heated up). At that point, the owner decided to fly his T182 home—which he did without incident—and have his regular mechanic ream the No. 3 exhaust valve guide. This appears to have resolved the issue once and for all.

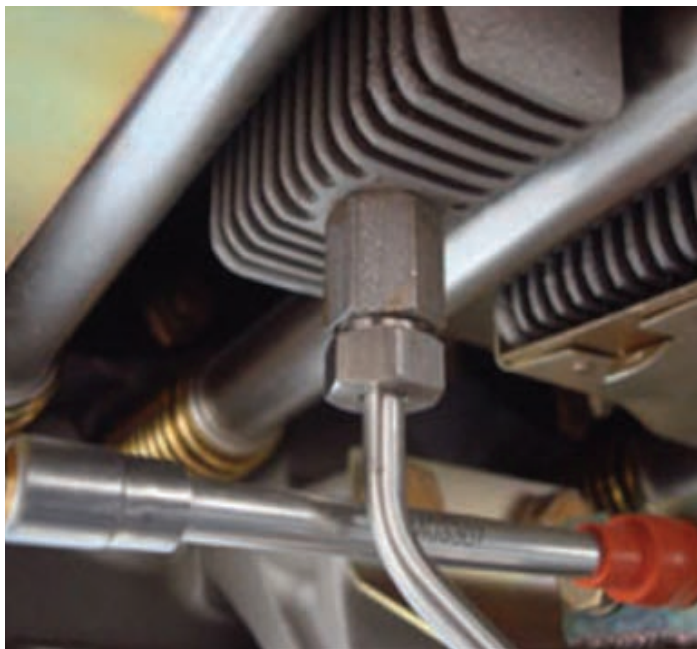
Our review of the data immediately confirmed our suspicions that the No. 6 CHT indication was bogus. At one point, its value changed more than 40°F between two adjacent data samples spaced six seconds apart. A 40°F change in CHT in six seconds is simply not possible—it defies the laws of physics. I've studied literally thousands of flights, and the most rapid CHT change I've ever seen—during a destructive pre-ignition event that wound up melting the piston—was about 1.5°F per second. This one

Figure 3—The CHT probes in Cirrus aircraft are notorious for failing and providing erroneous CHT data.

changed 7°F per second, and that’s simply not plausible. Clearly, the CHT No. 6 indication was lying, due either to a faulty probe or a bad connection.

We asked whether it was possible to have the No. 6 and No. 4 CHT probes swapped to verify that the anomalous CHT indication remained with the bad probe. Unfortunately, there were no services at this airport, and no mechanic available to swap the probes. After reviewing the engine monitor data, we were sufficiently confident in our diagnosis that we recommended that the owner fly the airplane home and have the CHT indication problem debugged there. The flight was uneventful, and the new engine is breaking in just fine.

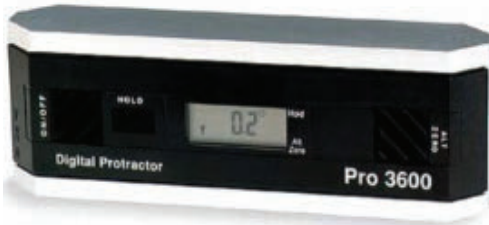
Figure 4—The \$360 Pro 3600 digital inclinometer turned out to be off by 3 degrees. The old-fashioned E25 “flowerpot” timing indicator got the job done.

was that at full takeoff power from approximately sea level, both post-annual flights had CHTs about 50°F higher and EGTs about 50°F lower than the pre-annual benchmark flight. I explained to the owner that this could mean only one thing: advanced magneto timing. I understood that the shop had just checked the mag timing and found it spot-on, but I also knew that the engine data wasn't lying, so I urged the owner to have the shop check the mag timing again. I said that the high-CHT/low-EGT condition I was seeing in the data would require that at least one magneto had timing advanced by 3 to 5 degrees.

Two hours later, I spoke with the DOM and the shop. He explained that he rechecked the mag timing, but this time instead of using the shop's fancy \$360 digital inclinometer, he used the old mechanical "flowerpot" timing tool that he'd used for more than 30 years before buying the digital unit. The flower pot revealed that the timing of both mags was advanced 3 degrees beyond the proper timing specification. The shop's \$300 digital inclinometer was off by 3 degrees. (I later learned that one of the technicians had accidentally dropped it on the concrete hangar floor, and it was never quite the same after that.)

You know the rest of the story. The shop readjusted the mag timing using the old flowerpot method, and the owner flew home with his EGTs and CHTs right where they were supposed to be.

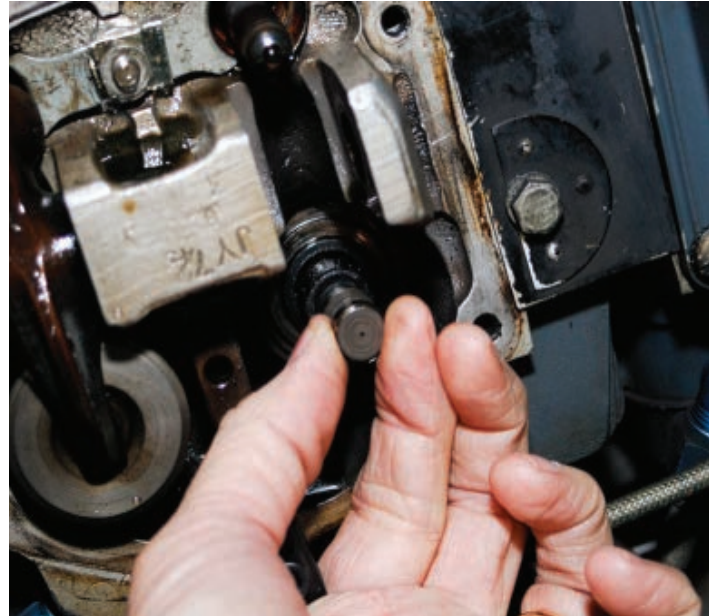
Figure 5—it makes no sense to do this sort of invasive exploratory surgery before first dumping and analyzing data from the digital engine monitor.

I checked compression No. 6 cylinder, 67/80 no leakage through the valves. I could hear some leakage through the rings until they clicked and seated during the compression check. I removed valves springs on intake and exhaust and found no excessive play in the guides, and all valves moved freely. I performed a third compression check of cylinder No. 6 with no valve springs installed and got 67/80. All lifters were replaced with new when the engine had a top overhaul about 900 hours ago. Lifters also were not found collapsed when rockers and springs were removed on the No. 6 cyl.

This airplane has a JPI engine monitor. Why didn't anyone think to dump the data and have it analyzed before starting to perform exploratory surgery on this engine—pulling spark plugs, fuel nozzles, rocker arms, valve springs, and so forth? To my way of thinking, that's like having a cough and going directly to a thoracic surgeon without first seeing an internist or radiologist for a physical exam or an X-ray. I e-mailed the IA and suggested he dump the JPI data and upload it so I could take a look at it. Film at 11. **EAA**
