SAVVY MAINTENANCE / OPINION

Fortunate catch

A maintenance-aware owner is the last line of defense

BY MIKE BUSCH

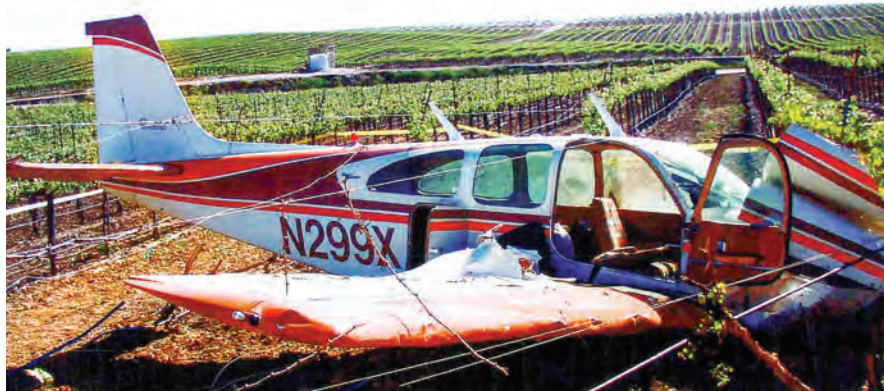
This 1966 Beechcraft Debonair crashed after the #4 cylinder and piston departed the engine in flight.

The post-accident engine examination revealed that the number 4 cylinder and piston had departed the engine in flight; they were never recovered. Two cylinder hold-down nuts had backed off their studs. The remaining four studs and both through-bolts were sheared off. The number 4 connecting rod, cap, and rod bolts and nuts were recovered from inside the engine cowling, as were most of the sheared-off studs, through-bolts, and nuts.

In reviewing the photographs taken during the NTSB’s examination of the engine, the plaintiff’s attorney discovered something crucial that the NTSB investigators missed: multiple dabs of light brown sealant on the mounting deck area of the crankcase where cylinders 2, 4, 5, and 6 were attached. This was the “smoking gun” that explained precisely why the number 4 cylinder departed the engine in-flight.

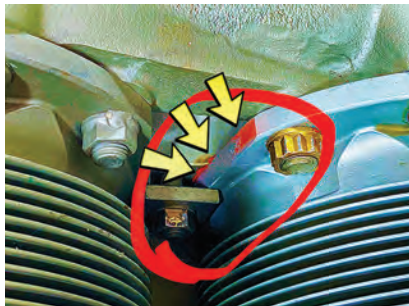
The red he saw was at the base of both cylinders. It was small and subtle enough that most owners would have missed it. But Corey looked at it closely, and it sure looked to him like high-temperature RTV—room temperature vulcanizing silicone rubber.

The red stuff that Corey noticed. Most owners would have missed it.

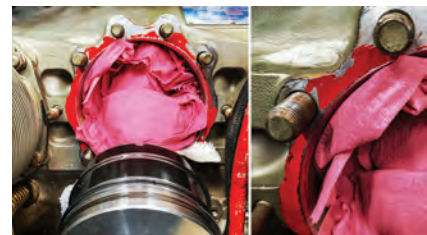
Corey showed this warning to the shop's director of maintenance, who quickly admitted that they'd made a mistake and would remove the cylinders again to correct it. Once the cylinders were off, Corey was shocked at the quantity of red RTV he saw on the mounting deck area of the crankcase. The mechanic who had installed the cylinders explained that he'd applied some red RTV to the cylinder base seal (O-ring) in hopes that this would help prevent oil leakage, and obviously the RTV had extruded onto the mounting

What Corey saw after the cylinders were removed.

deck area as the cylinder hold-down nuts were torqued.

Corey made sure that every bit of the RTV was scrubbed from the mounting deck and cylinder base flanges, and that new base seals were used when the cylinders were installed once again.

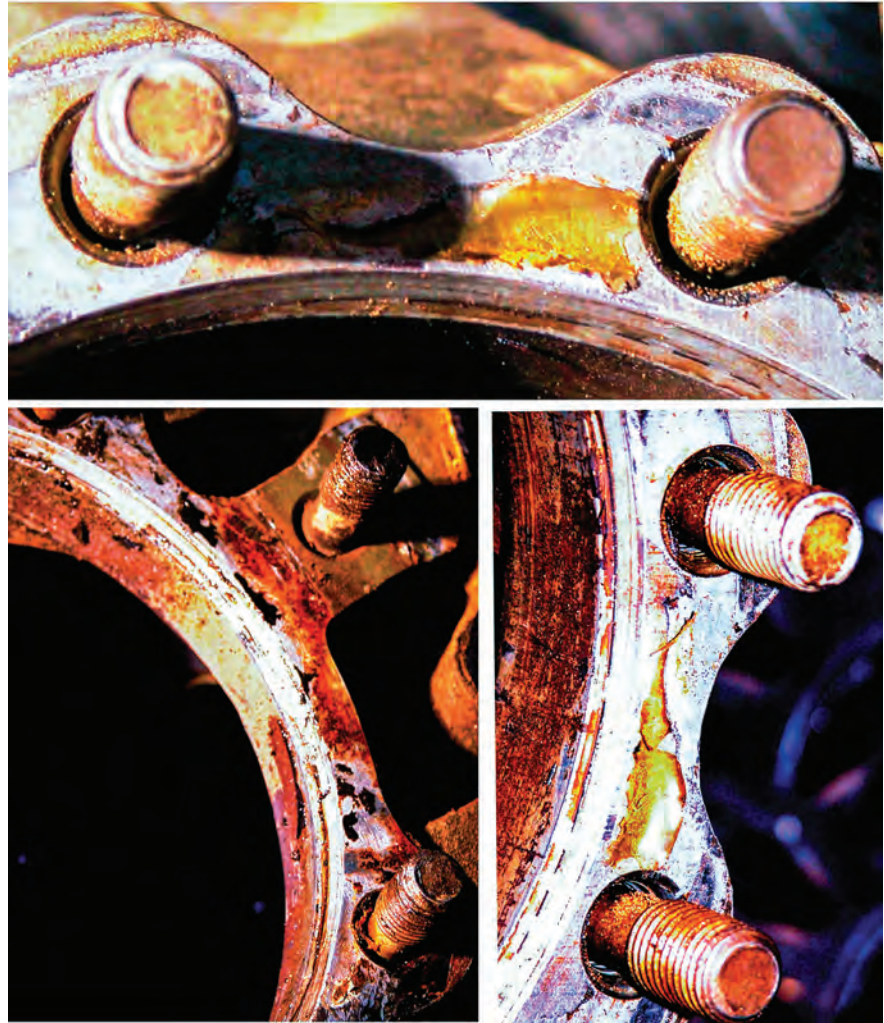
Sealant applied to the cylinder base seals had extruded onto the crankcase mounting decks.
