How Much Is Too Much?

There's metal in your oil filter. Now what?

Sport Aviation January 2013 PHOTOGRAPHY COURTESY MIKE BUSCH

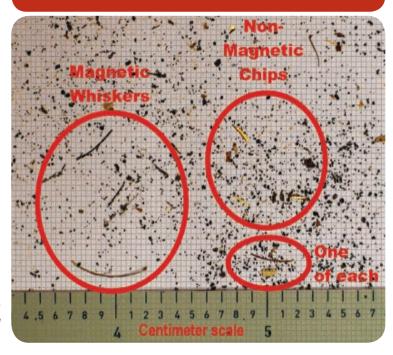
Figure 1—Photo of what was found in Frank's oil filter. Ultimately, it was identified as residual metal from a slipping starter adapter.

I asked Frank to e-mail me a photo of the filter contents, and he did. (See Figure 1.) I saw a few curved magnetic whiskers and a few small bronze-colored chips. Certainly enough to get my attention and pique my curiosity about their source, but hardly anywhere close to warranting a \$20,000 engine teardown.

I asked Frank a few follow-up questions and learned that his engine's starter drive adapter had recently started slipping and had been replaced. The small quantity of metal in the filter struck me as being entirely consistent with what one would expect to see from a failing starter drive adapter. So I advised Frank to have his mechanic change the oil and oil filter, then go fly the airplane for 10 hours or so, and then have the new oil filter cut open and inspected. I added that tearing down the engine because of such a small quantity of easily explainable metal in the oil filter struck me as being a grotesque overreaction on the part of his mechanic.

A few days later, my friend e-mailed me to let me know that they'd examined Frank's filter contents and clearly established that the metal was indeed from the starter adapter, just as I suspected. At my request, he then sent an e-mail to Frank's

replacement, and asked whether he agreed that the metal most likely came from the now-replaced starter adapter. He nodded. I asked whether he thought a reasonable course of action would be to change the oil and filter, fly another 10 hours, and then check the filter again. He agreed that was a good plan.

mechanic recommending that the aircraft be flown for 10 hours and the filter cut open and inspected.

After receiving guidance directly from the engine manufacturer, Frank's mechanic relented and agreed to sign off the annual. Some weeks later, Frank brought the airplane back to the shop after flying it for about 10 hours. The mechanic cut open the filter and found it to be free of any metal.

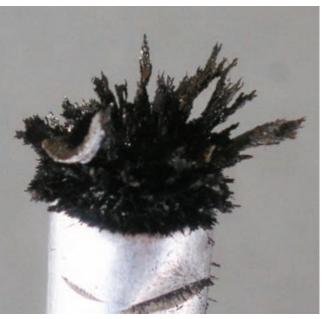
By the way, 1/4 teaspoon of metal is a *lot* of metal! (See Figure 3.)

Figure 3—A 1/4 teaspoon of metal is a lot of metal!

- If the filter contains less than 1/8 teaspoon of metal particles, flakes, or whiskers, change the oil and filter, fly the engine for 25 hours, then cut open and inspect the new filter.
- If the filter contains between 1/8 and 1/4 teaspoon of metal particles, flakes, or whiskers, change the oil and filter, fly the engine for 10 hours, then cut open and inspect the new filter.
- If the filter contains any large pieces of metal the size of a broken lead pencil point or larger (1/16 inch in diameter), or contains more than 1/4 teaspoon of metal particles, flakes, or whiskers, ground the engine until the source of the metal is determined.
