# Actionable intelligence from big data

Comparing individual aircraft to others of their ilk.

BY MIKE BUSCH

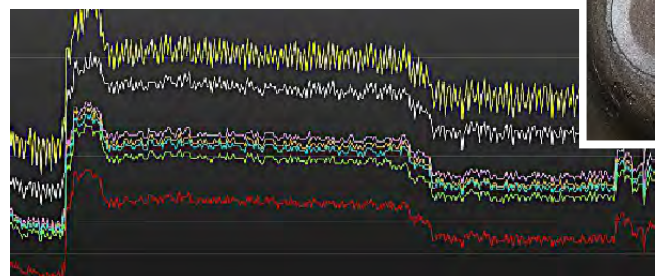
**DISTINCT OSCILLATIONS** in the exhaust gas temperature of cylinder number 3 (in yellow) show the exhaust valve in this Cessna 340 is on the verge of failing. (The owner didn't upload his data for analysis until after the valve did fail.)

A Cessna 340 also generated a FEVA alert (opposite page). The slow, rhythmic oscillation of EGT number 3 (yellow trace) is quite obvious, and is also reflected in a more subtle oscillation of TIT (white trace), while the other five cylinders look normal. The owner found (and photographed) a failed exhaust valve when cylinder number 3 was pulled.

Unfortunately, this Cessna 340's owner wasn't in the habit of uploading his data on a regular basis. He didn't upload this data until after his engine started running rough, so he didn't receive a FEVA alert in time to head off the valve failure. The moral of this story is obvious.
