# It's baffling

Rigid baffles and flexible baffle seals are critical to keeping your engine cool

BY MIKE BUSCH

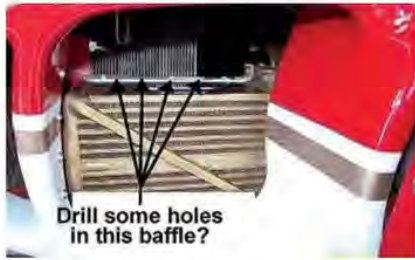
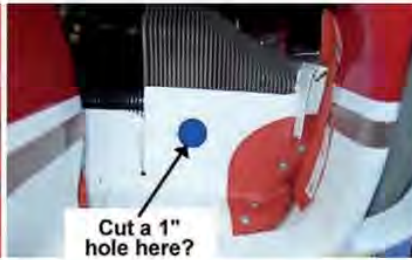
THE T210 OWNER'S IDEAS for modifying his cooling baffles would not have been a good idea.

**THE CESSNA T210 OWNER** was clearly frustrated with his new engine installation. “I recently had my engine rebuilt and had a new baffle kit installed. The cylinder head temperatures for cylinders 5 and 6 are always 20 degrees to 30 degrees Fahrenheit hotter than the rest. During climb the difference gets even bigger. Cylinder 5 and 6 CHTs are very difficult to keep below 400 degrees during a climb, even with the cowl flaps open and full-rich mixture. Should I consider giving them some air? On cylinder 6, why not cut one or more holes in the white aluminum baffle in front of the cylinder? On cylinder 5, why not drill one or more holes in the horizontal aluminum plate located behind the oil cooler?”

After looking at the marked-up photo from the T210 owner, I replied that cutting holes in the baffles was definitely not a good idea, and that doing so would undoubtedly make the cooling problems worse, not better. It was apparent that this owner didn't understand how the powerplant cooling

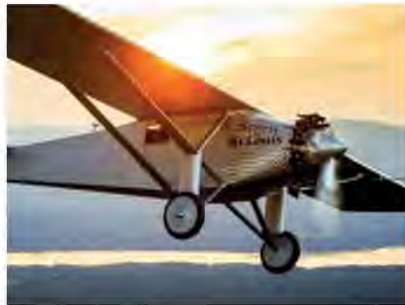
EARLY AIRCRAFT ENGINES were velocity cooled, but this isn't practical for today's high-performance engines and low-drag airframes.

In the early days of aviation, aircraft designers took a simple approach to the problem of cooling aircraft engines. The engines were mounted with their finned cylinders out in the slipstream and cooled by the horizontal flow of ram air. This design is known as “velocity cooling” and was adequate for cooling the low-compression, single-row radial engines of the time.

As engines grew more powerful and multirow radials and horizontally opposed engines came into fashion, it became obvious that simple velocity cooling wasn't up to the job. For one thing, cooling was uneven—front cylinders got a lot more cooling airflow than rear ones. For another, sticking all those cylinders out in the breeze created horrendous cooling drag. A better scheme was obviously needed.

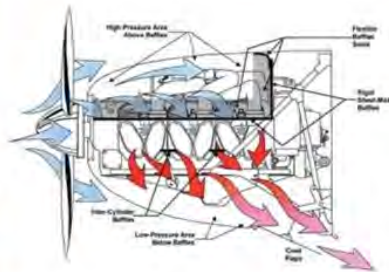
MODERN 'PRESSURE-COOLED' ENGINES rely on rigid baffles and flexible baffle seals that divide the engine compartment into high- and low-pressure chambers. Cooling airflow is usually top to bottom, not front to back.

That better system was known as “pressure cooling” and is the method used in all modern piston aircraft. Pressure cooling is accomplished by placing a cowling around the engine and using a system of rigid baffles and flexible baffle seals to produce the volume and pattern of cooling airflow necessary to achieve even cooling with minimum drag.

The volume of cooling airflow that passes across the cylinders is a function of the pressure differential between the upper (high-pressure) chamber and the lower (low-pressure) chamber of the engine compartment. This pressure differential is known as “delta P.” Cowl flaps are often used to modulate the cooling airflow. Opening the cowl flaps reduces the air pressure in the lower chamber, thereby increasing delta P and consequently the volume of cooling air that passes vertically across the cylinder fins.

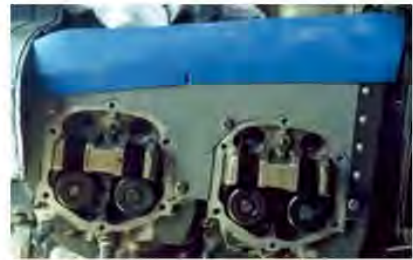
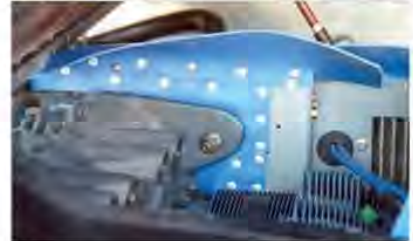
FLEXIBLE SEALS prevent air from escaping through the gaps between the engine-mounted baffles and the cowling, and must curve toward the high-pressure chamber.

One of the most problematic parts of the cooling system is the system of flexible baffle seals. These strips—usually made of high-temp silicone rubber—are used to seal the gaps between the sheet metal baffles and the cowling. These gaps are necessary because the baffles move around inside the cowling as the engine rocks on its shock mounts.

To do their job, the seals must curve up and forward into the high-pressure chamber, so that the delta P presses the seals tightly against the cowling. If the seals are permitted to curve away from the high-pressure area—not hard to do when

reinstalling the cowling if you're not careful—they will blow away from the cowling in flight and permit large amounts of precious cooling air to escape.

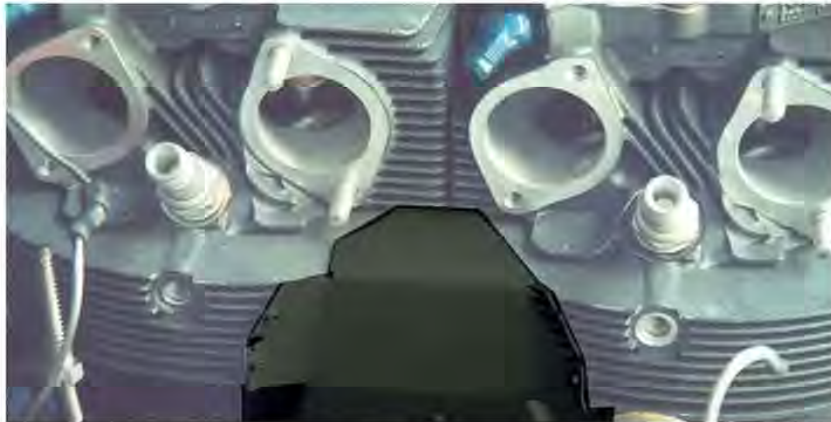
**INTERCYLINDER Baffles** are oddly-shaped pieces of sheet metal that mount beneath and between the cylinders, and force the down-flowing cooling air to wrap around and cool the bottom of the cylinders.

baffles (see “Savvy Maintenance: Good Eyes,” November 2020 *AOPA Pilot*). These small, odd-shaped pieces of sheet metal are mounted below and between the cylinders. Their purpose is to prevent cooling air from passing through the spaces between adjacent cylinders, and to force the down-flowing cooling air to wrap around and cool the bottom of the cylinders, rather than just cooling the top and sides. These baffles are critical for proper cooling, but they’re difficult to see unless you know exactly where to look for them. During engine installation or cylinder replacement, it’s not at all uncommon for them to be left out or mispositioned, and it’s not unheard of for them to vibrate loose and fall out during engine operation. Hot-running cylinders are the inevitable result.

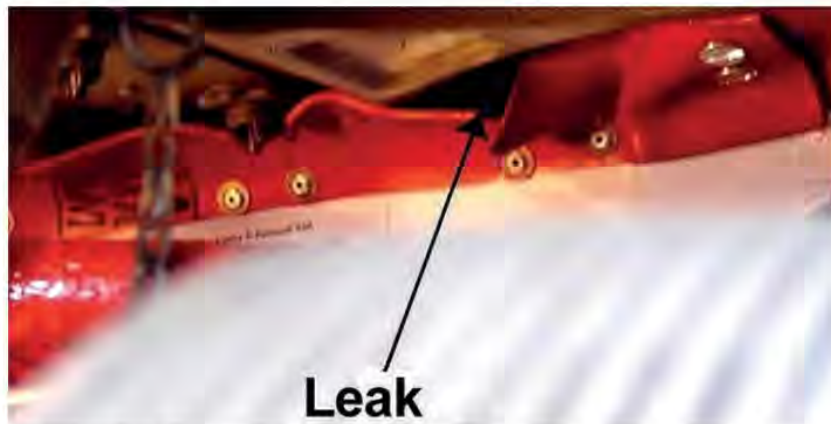
**THIS SIGNIFICANT COOLING AIR LEAK**, resulting from a wrinkle in a flexible baffle seal, is what caused the T210 CHTs to run so hot.

One of those photos revealed a rather significant cooling air leak caused by a wrinkle in a flexible baffle seal. This problem was apparent only with the top cowl installed and could be seen by inspecting through the front intake openings using a flashlight. Savvy pilots who understand the importance of baffles and seals look for this sort of thing during preflight inspection. Since mechanics do most of their inspecting with the cowlings removed, problems like this sometimes escape their detection.

I studied the photos and continued my email dialogue with the T210 owner. Between the two of us, we managed to identify a dozen leaks in the T210’s baffle system. Some were small, others more serious. Combined, they accounted for a significant loss of cooling efficiency. With a little trimming of the flexible seal strips plus a few well-placed dabs of high-temp RTV sealant, the owner succeeded in plugging the leaks in short order and reported that his engine was running noticeably cooler. **AOPA**
