Ending the war on jugs

Weak compression doesn't always mean the cylinder must come off

BY MIKE BUSCH A&P/IA

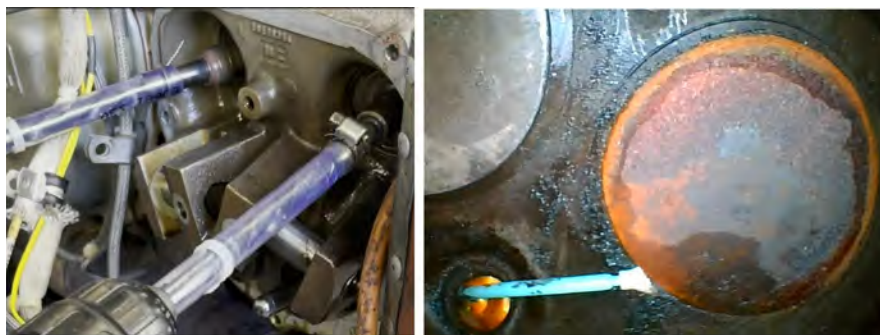
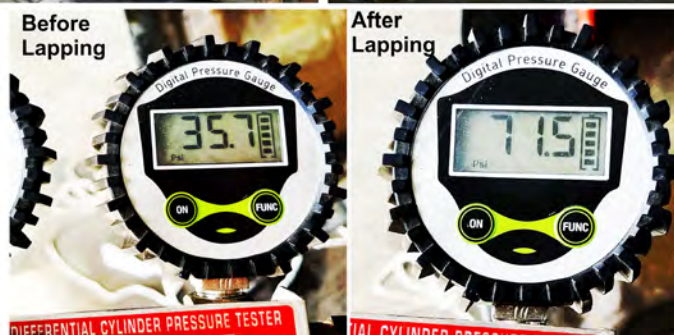
Lapping an exhaust valve in place without removing the cylinder or dropping the exhaust.

Dropping the exhaust on my turbo-charged engines is a pain in the patoot, so I decided to see whether I could figure out how to lap the valve without dropping the exhaust, working only through the two spark plug openings. After a bit of experimenting, I developed a technique for doing this using some gun cleaning applicator swabs that I bent using a heat gun so they could be inserted through the bottom spark plug boss—while viewing with a borescope through the top spark plug boss—and maneuvering the applicator tip between the exhaust valve and seat. I made a YouTube video demonstrating this technique that you can access online (bit.ly/lapping-in-place).

My initial attempt brought the compression of the number 6 cylinder up from 36/80 to 72/80. However, when I reinspected the valve 15 hours later, the valve still had an asymmetrical heat signature although the compression was good. I consulted with Pasquale, who told me, “You probably didn’t lap it aggressively enough—rookie mistake.” So, I lapped the valve again using more iterations and more elbow grease. When I borescoped the valve 15 hours later, the heat signature was a perfectly symmetrical bull’s-eye pattern.
