Mark's beautiful 1980 Cessna 185A.

AOG Rescue

A mechanical problem away from home is every aircraft owner's worst nightmare

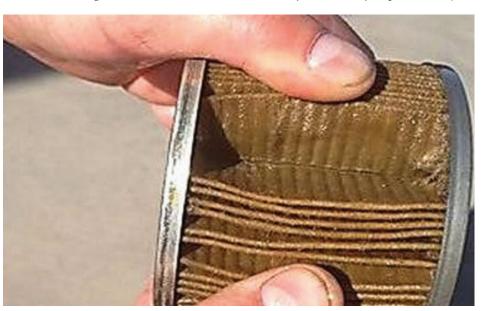
After successfully extracting his aircraft from Mr. T's shop, Mark taxied over to the FBO and asked if he could use its hangar. They said he could. Following my advice, Mark drained the oil through several layers of cheesecloth, which he then inspected carefully and reported to me that there was no metal visible. Mark texted me another iPhone photo that showed oily cheesecloth in a funnel with nothing "interesting" in it.

Mark strained his engine oil through cheesecloth to make sure the little chunk of aluminum found in his oil pressure relief valve "didn't have a bunch of brothers and sisters floating around in the oil pan."

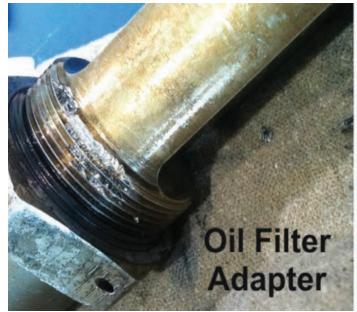
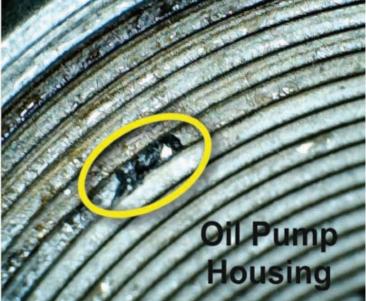
Not long after Mark got his airplane home, I recommended that he take it to a very good Cessna service center in Northern California for its annual ordeal. In the course of the annual inspection, the shop found exactly where that little chunk of aluminum in the oil pressure relief valve had come from. It turned out that the oil filter adapter's jam nut had worked loose, and the adapter was vibrating and chewing up the threads in the aluminum oil pump housing. (This problem is so commonplace that there's a recurring AD against the oil filter adapter.) The shop installed a new pump housing and oil filter adapter. Mystery solved!

Source of the aluminum chunk found in the pressure relief valve: torn-up threads in the oil pump caused by a loose oil filter adapter. Mystery solved!
