SAVVY MAINTENANCE / OPINION

Fortunate catch

A maintenance-aware owner is the last line of defense

BY MIKE BUSCH

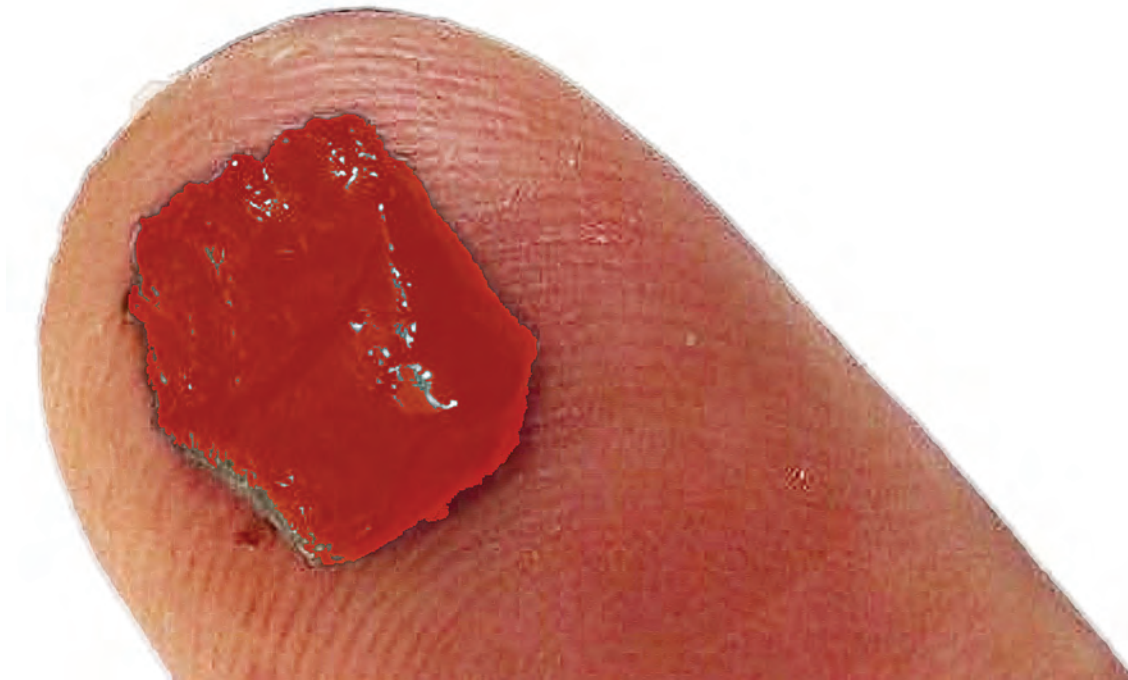
almost ready for the break-in flight, Corey went over to eyeball his newly installed jugs—and he saw red.

Red stuff

The red he saw was at the base of both cylinders. It was small and subtle enough that most owners would have missed it. But Corey looked at it closely, and it sure looked to him like high-temperature RTV—room temperature vulcanizing silicone rubber.

Corey showed this warning to the shop's director of maintenance, who quickly admitted that they'd made a mistake and would remove the cylinders again to correct it. Once the cylinders were off, Corey was shocked at the quantity of red RTV he saw on the mounting deck area of the crankcase. The mechanic who had installed the cylinders explained that he'd applied some red RTV to the cylinder base seal (O-ring) in hopes that this would help prevent oil leakage, and obviously the RTV had extruded onto the mounting
