COMMENTARY / SAVVY AVIATOR

AOG Rescue

A mechanical problem away from home is every aircraft owner's worst nightmare

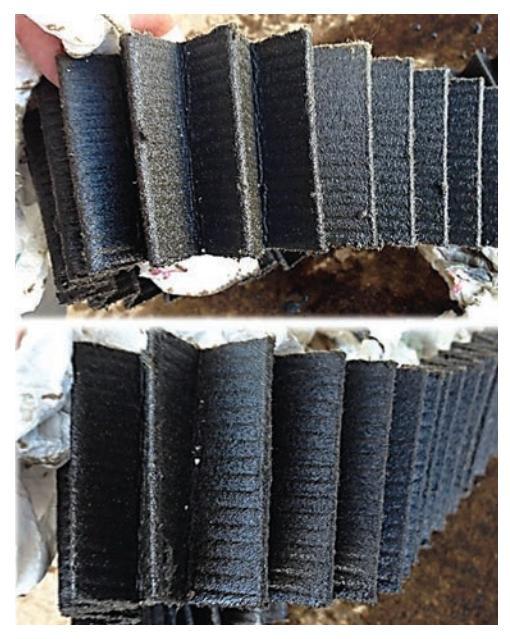
I studied the photos of Mark's oil filter and saw a few flecks of metal there, but certainly nothing that I felt was significant enough to warrant an engine teardown.

I asked if Mark could send me some high-resolution photographs of the metal that the mechanic found in the oil filter. He snapped a series of nice photos with his iPhone and sent them to me. It looked to me as if there were only a few small flecks of metal in the filter. I saw nothing that I would consider to be "significant." Certainly nothing significant enough for me to conclude the

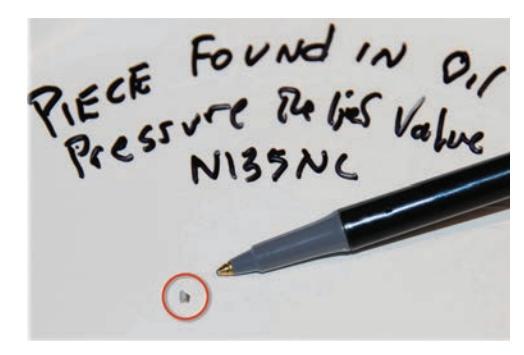
A small chunk of aluminum about 1/32-inch in diameter was found in the oil pressure relief valve and was the cause of no oil pressure at engine start.

I asked if Mark was sure there was enough oil in the sump, and he assured me that was the first thing he checked. I explained that by far the most likely reason for a loss of oil pressure (other than not enough oil) was contamination of the oil pressure relief valve. The oil pressure relief valve is located on the back of the oil pump, and it regulates engine oil pressure. It's a dead-simple device, consisting of a steel plunger that is spring-loaded to press against a seat, and has an adjustment screw that controls the spring tension. I suggested that Mark ask the A&P to remove the oil pressure relief valve housing and inspect the valve for the presence of foreign material that might be preventing the plunger from making good contact with the seat.

A half-hour later, Mark texted me another photo showing a small metal particle that the mechanic found lodged in the oil pressure relief valve. I inquired whether or not the piece of metal was ferrous (i.e., would stick to a magnet). Mark checked it with a magnet and reported that it was nonmagnetic. Based on that fact, and the apparent color of the piece of metal (which we both agreed was "silvery" and not "coppery"), we concluded that it was almost certainly a small chunk of aluminum. I estimated its size as roughly 1/32 of an inch in diameter, give or take.

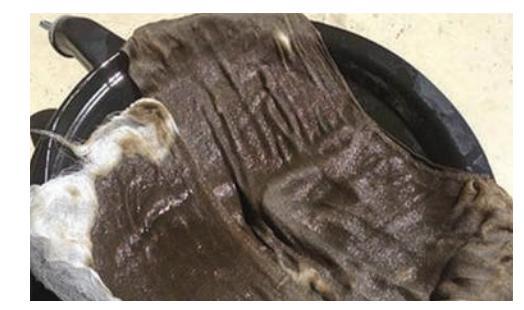
Mark strained his engine oil through cheesecloth to make sure the little chunk of aluminum found in his oil pressure relief valve "didn't have a bunch of brothers and sisters floating around in the oil pan."

After successfully extracting his aircraft from Mr. T's shop, Mark taxied over to the FBO and asked if he could use its hangar. They said he could. Following my advice, Mark drained the oil through several layers of cheesecloth, which he then inspected carefully and reported to me that there was no metal visible. Mark texted me another iPhone photo that showed oily cheesecloth in a funnel with nothing "interesting" in it.

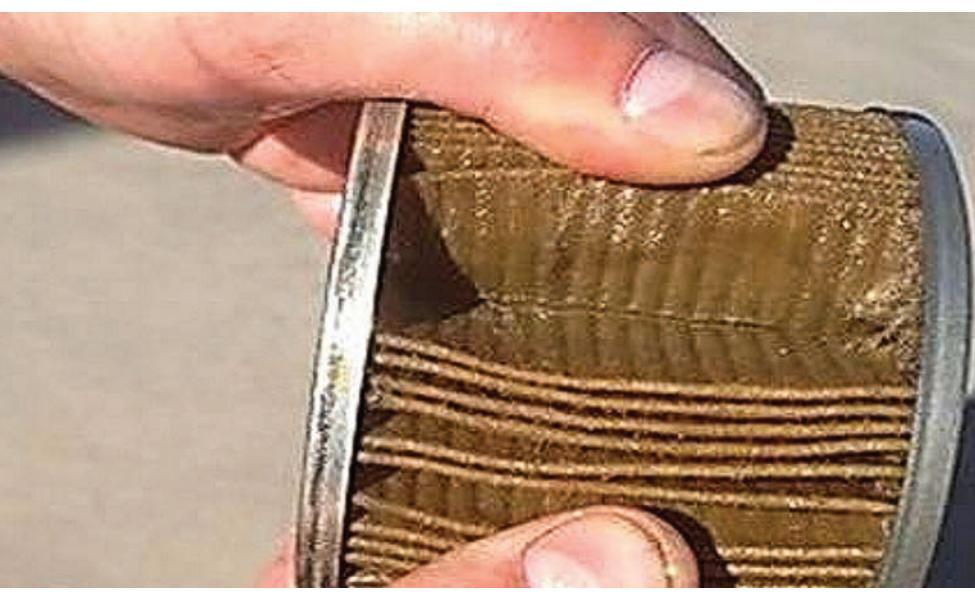
After a 30-minute ground run and a full-power high-speed taxi run, the oil filter was spotless.

I had Mark service the engine with fresh oil, cowl it up, and perform a 30-minute ground run, varying the rpm between 1000 and 1700. He reported to me that oil pressure started a bit above the green arc, but as the oil temperature came up the pressure stabilized at 50 psi, exactly where it should be. I then had Mark perform a high-speed taxi test at full takeoff power on the 7,400-foot runway.

After taxiing back to the FBO, Mark uncowled the engine and cut open the oil filter. It was absolutely spotless, with no signs of metal whatsoever. He installed a new oil filter and cowled everything back up.

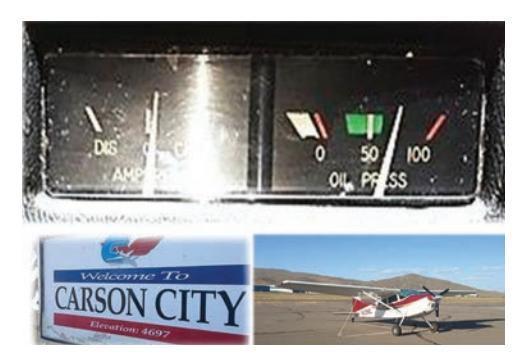
On the ground at Carson City. The oil pressure was rock-solid all the way at 50 psi.

proceeded to take off from Minden and fly to the next airport up the valley, Carson City, where he wisely decided to remain overnight. The short flight was completely uneventful, and the oil pressure was rock solid from takeoff to touchdown. After landing, he texted me three more photos, one of the oil pressure gauge with the needle two-thirds of the way up the green arc, a second of the big sign saying "Welcome to Carson City," and a third of his beautiful Cessna 185 on the tiedown at Carson Airport.

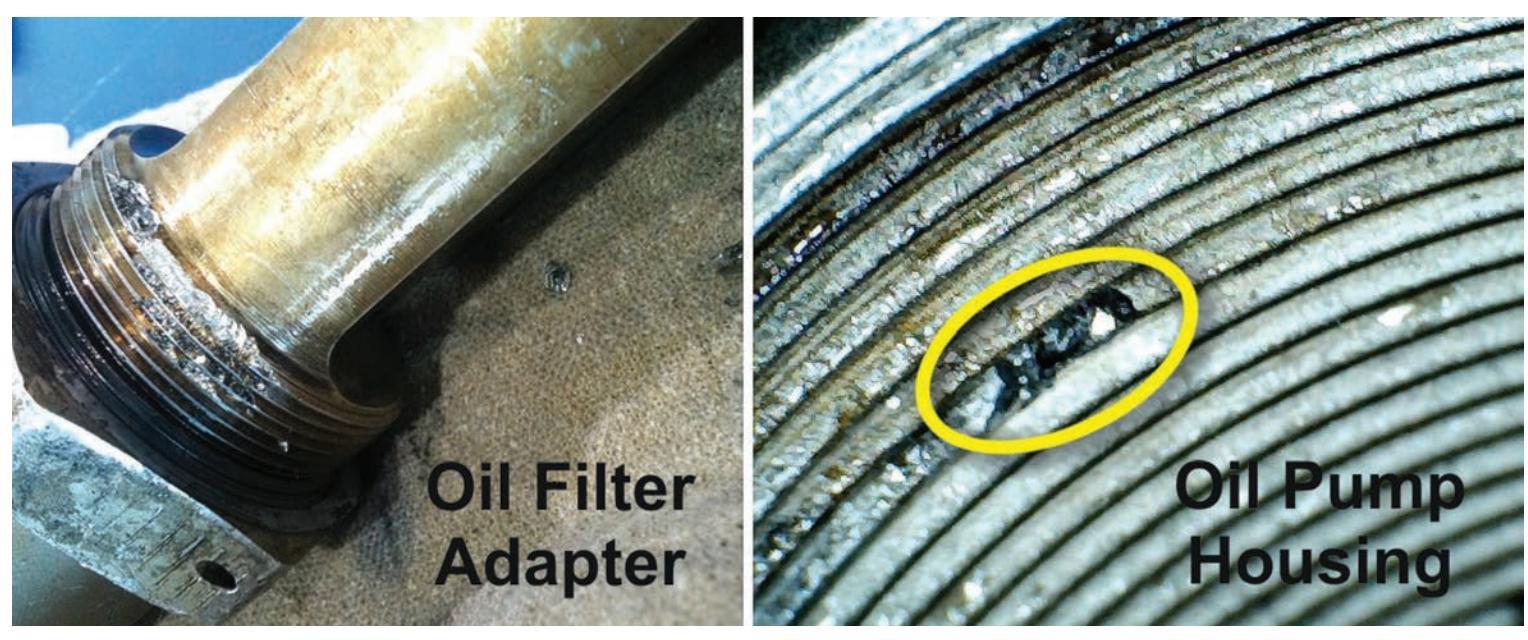
Source of the aluminum chunk found in the pressure relief valve: torn-up threads in the oil pump caused by a loose oil filter adapter. Mystery solved!

Not long after Mark got his airplane home, I recommended that he take it to a very good Cessna service center in Northern California for its annual ordeal. In the course of the annual inspection, the shop found exactly where that little chunk of aluminum in the oil pressure relief valve had come from. It turned out that the oil filter adapter's jam nut had worked loose, and the adapter was vibrating and chewing up the threads in the aluminum oil pump housing. (This problem is so commonplace that there's a recurring AD against the oil filter adapter.) The shop installed a new pump housing and oil filter adapter. Mystery solved! **E44**
